DECISION DOCUMENT

January, 1988

DDT Contaminated Areas

Redstone Arsenal

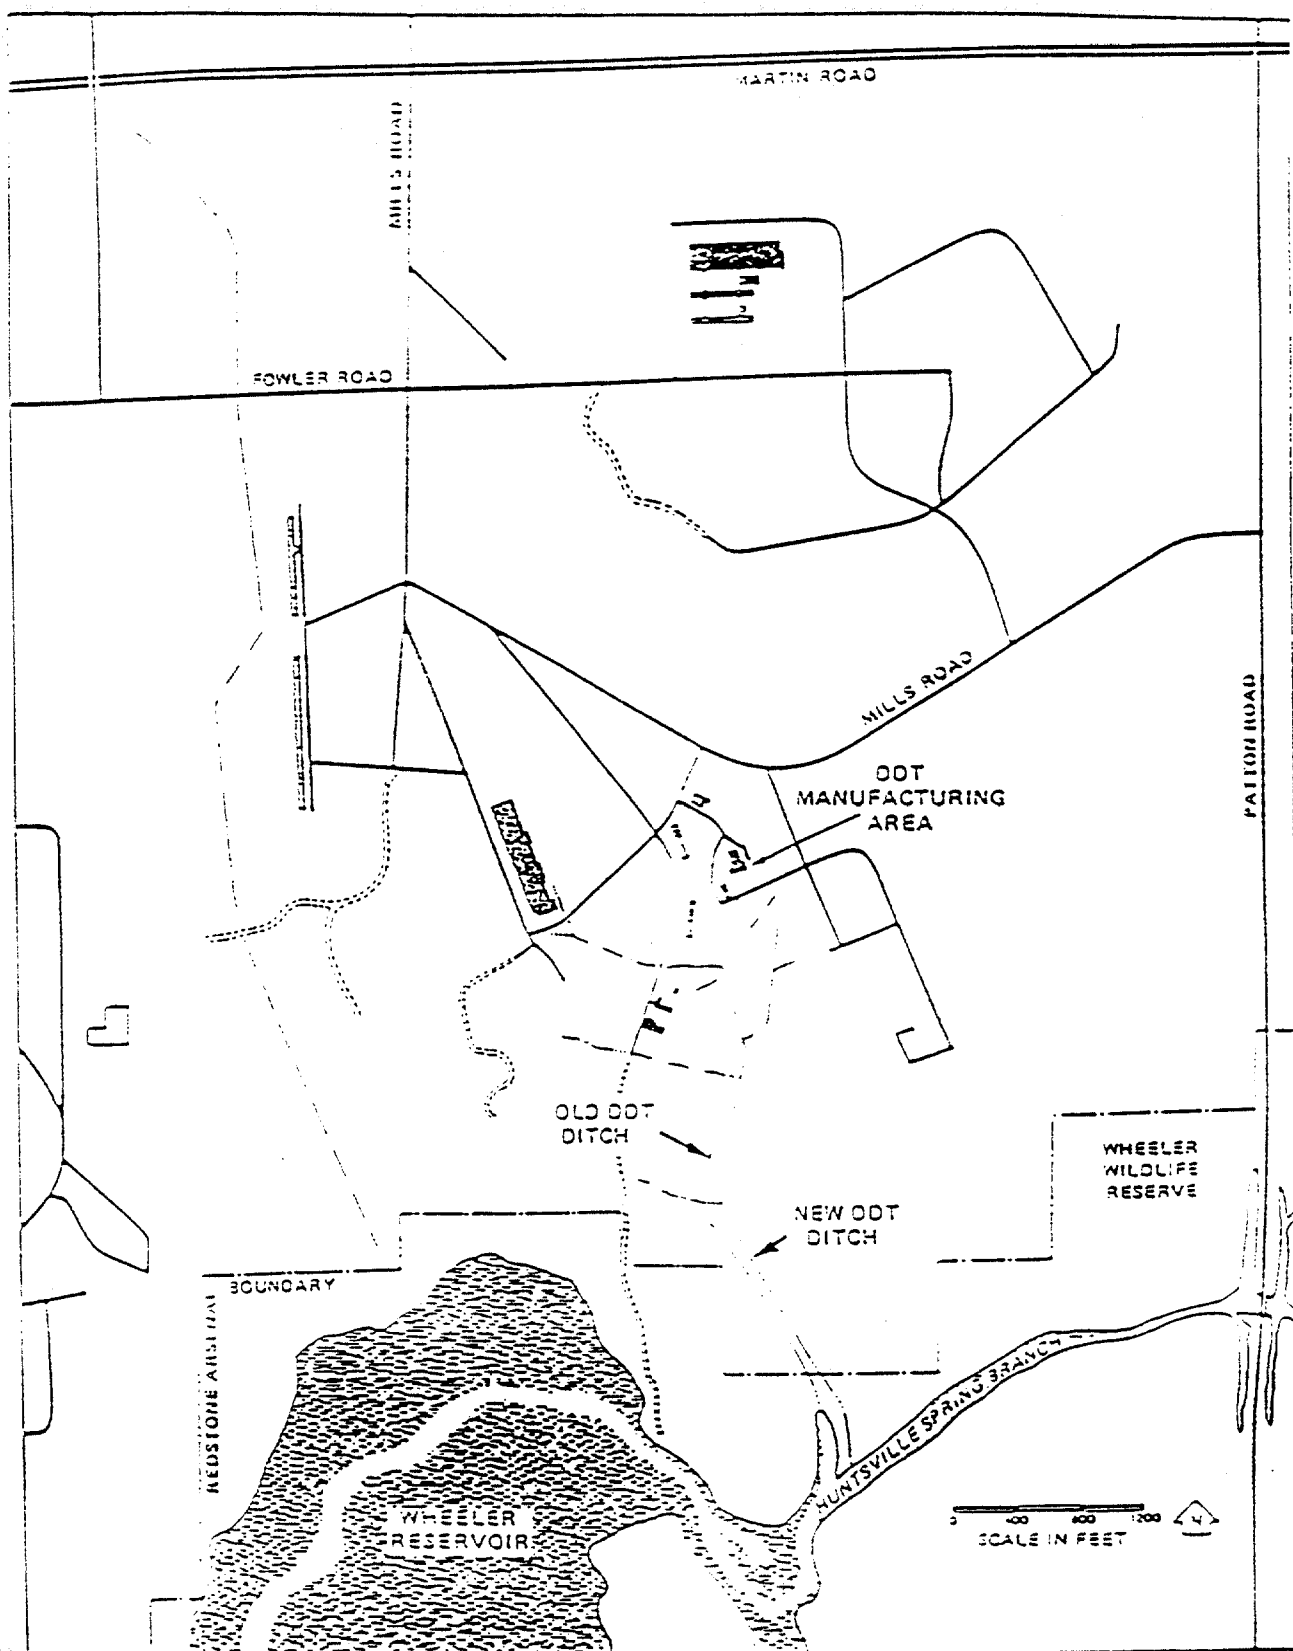
Figure 3. DDT Manufacturing Area and DDT Discharge Ditch
Source: Water and Air Research, Inc., 1983

In 1947, the Calabama Chemical Company leased a manufacturing plant (formerly called the Thionyl Chloride Plant) in the 5000 acre area of RSA, approximately 2500 feet north of Huntsville Spring Branch (HSB) to manufacture up to 25 million pounds of DDT per year. As part of the manufacturing process, crystalline DDT was washed with water. The contaminated process and cooling waters were discharged directly into the Huntsville Spring Branch at an estimated rate of 1.5 million gallons per day (MGD). DDT levels in the wastewater measured up to 0.5 mg/L, mainly as particulates (USPHS, 1964). In 1954, the DDT plant lease was taken over by Olin Mathiesen Chemical Company, who in January, 1965, constructed a settling pond to meet a new water concentration standard of 10 parts per billion (ppb). The pond was cleaned periodically, and the residues were buried in nearby landfills. Plant personnel estimated that 12,000 pounds of DDT accumulated by sedimentation in 4 months in the settling pond (USAEHA, 1965), a period during which the production was estimated at 1 to 2 million pounds of DDT per month (USPHS, 1964). Because of problems in meeting the 10 ppb standard as a result of accumulation of DDT in the drainage ditch, a new ditch was dug in June, 1967, parallel to the old ditch. The DDT in the old ditch was neutralized with lime and ferrous sulfate.

Revision of the original 10 ppb standard to 20 ppt (parts per trillion) of DDT in water in October 1969 led to cutbacks in the DDT production. In July, 1970, Olin began adding lime and ferrous sulfate to the pond and the ditch to neutralize DDT the residues. The plant was closed and vacated in November 1971 and demolished in 1972. Sampling of the drainage ditch in April 1977 indicated DDT levels of 66 ppb in water samples and 1385 ppm in the sediment. DDT deposits on the surface of the old manufacturing site measured 98 percent DDT. The results of sediment and biological sample analyses indicated widespread DDT contamination around the ditch, Huntsville Spring Branch, Indian Creek and downstream to the Tennessee River (Figure 2).

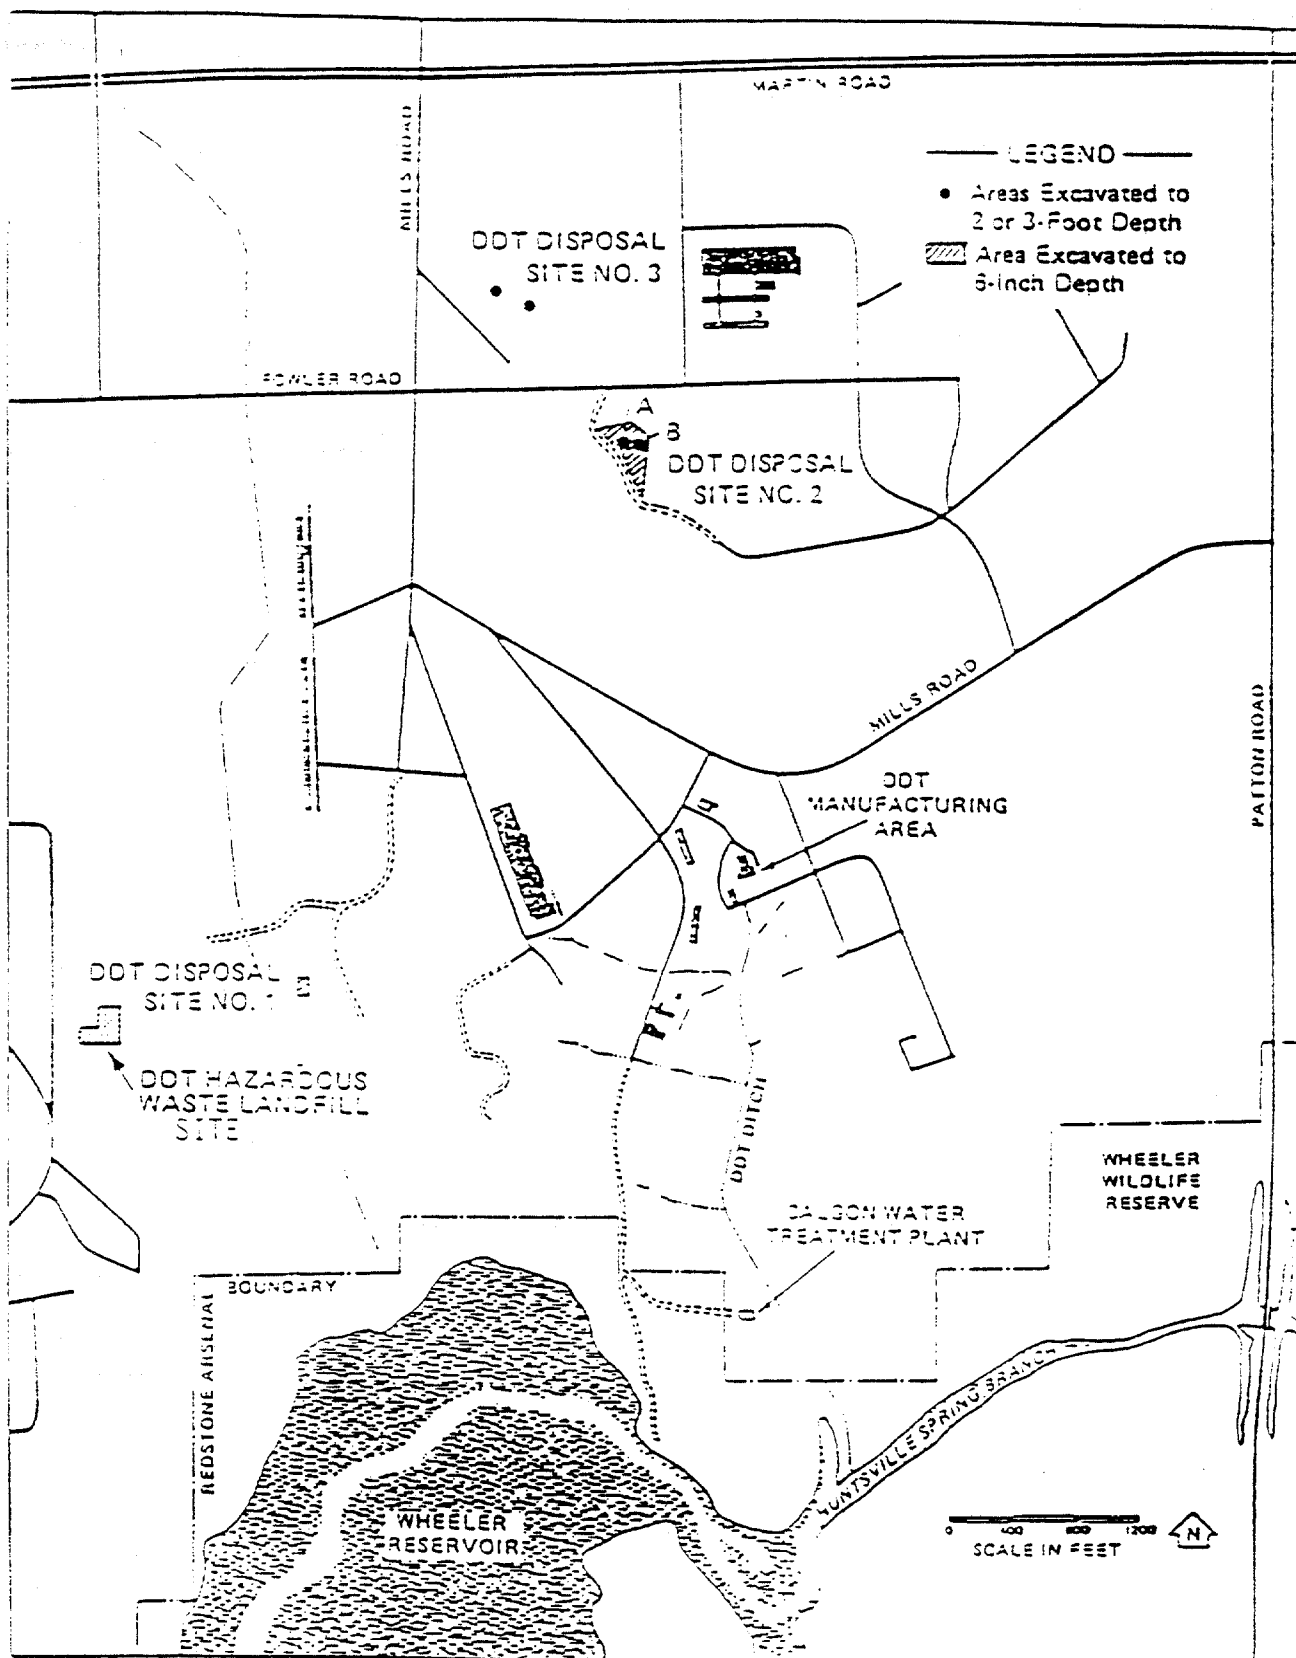
Figure 4. Location Map - Collection and Disposal of DDT-contaminated Materials

The mean total DDT concentration in soil samples collected in the DDT manufacturing area measured as high as 7500 mg/kg (8 samples). The mean concentration of total DDT in surface water samples collected at the manufacturing site was 0.073 mg/L. However, the levels of total DDT in the surface water samples indicated the presence of particulate matter because the solubility of DDT in water is below 2 ug/L. These results are summarized in Table 1. Figure 4 shows the sampling points.

1. Construction of a hazardous waste landfill at PSA to dispose of DDT contaminated materials. The landfill was constructed under a permit issued by the State of Alabama to provide a secure disposal site for DDT contaminated materials removed from the manufacturing site and associated dumps and drainage ditches. The soil parameters were examined to verify the suitability of the site. The sides and bottoms of the pits of the landfill consisted of a minimum of two feet of natural or implaced low-permeability compacted clay. Soils and other DDT contaminated materials were placed in the pits (of the landfill) in one foot layers and compacted by a minimum of six passes with a vibrating roller. Rain water which had collected in the pits was pumped to the Calgon WTP for treatment. After each pit was filled, it was sealed with two feet of compacted clay. Groundwater monitoring wells were installed at the time of the landfill construction. Periodic maintenance and monitoring has been carried out since the construction.

2. Restoration of the DDT manufacturing site, including partial demolition of the manufacturing building, plugging of pipes and sewers, and excavation of DDT contaminated materials.

3. Excavation and disposal of contaminated material from the DDT ditch.

4. Cleanup of former DDT waste disposal areas. The soils and debris were excavated and placed in the hazardous waste landfill.

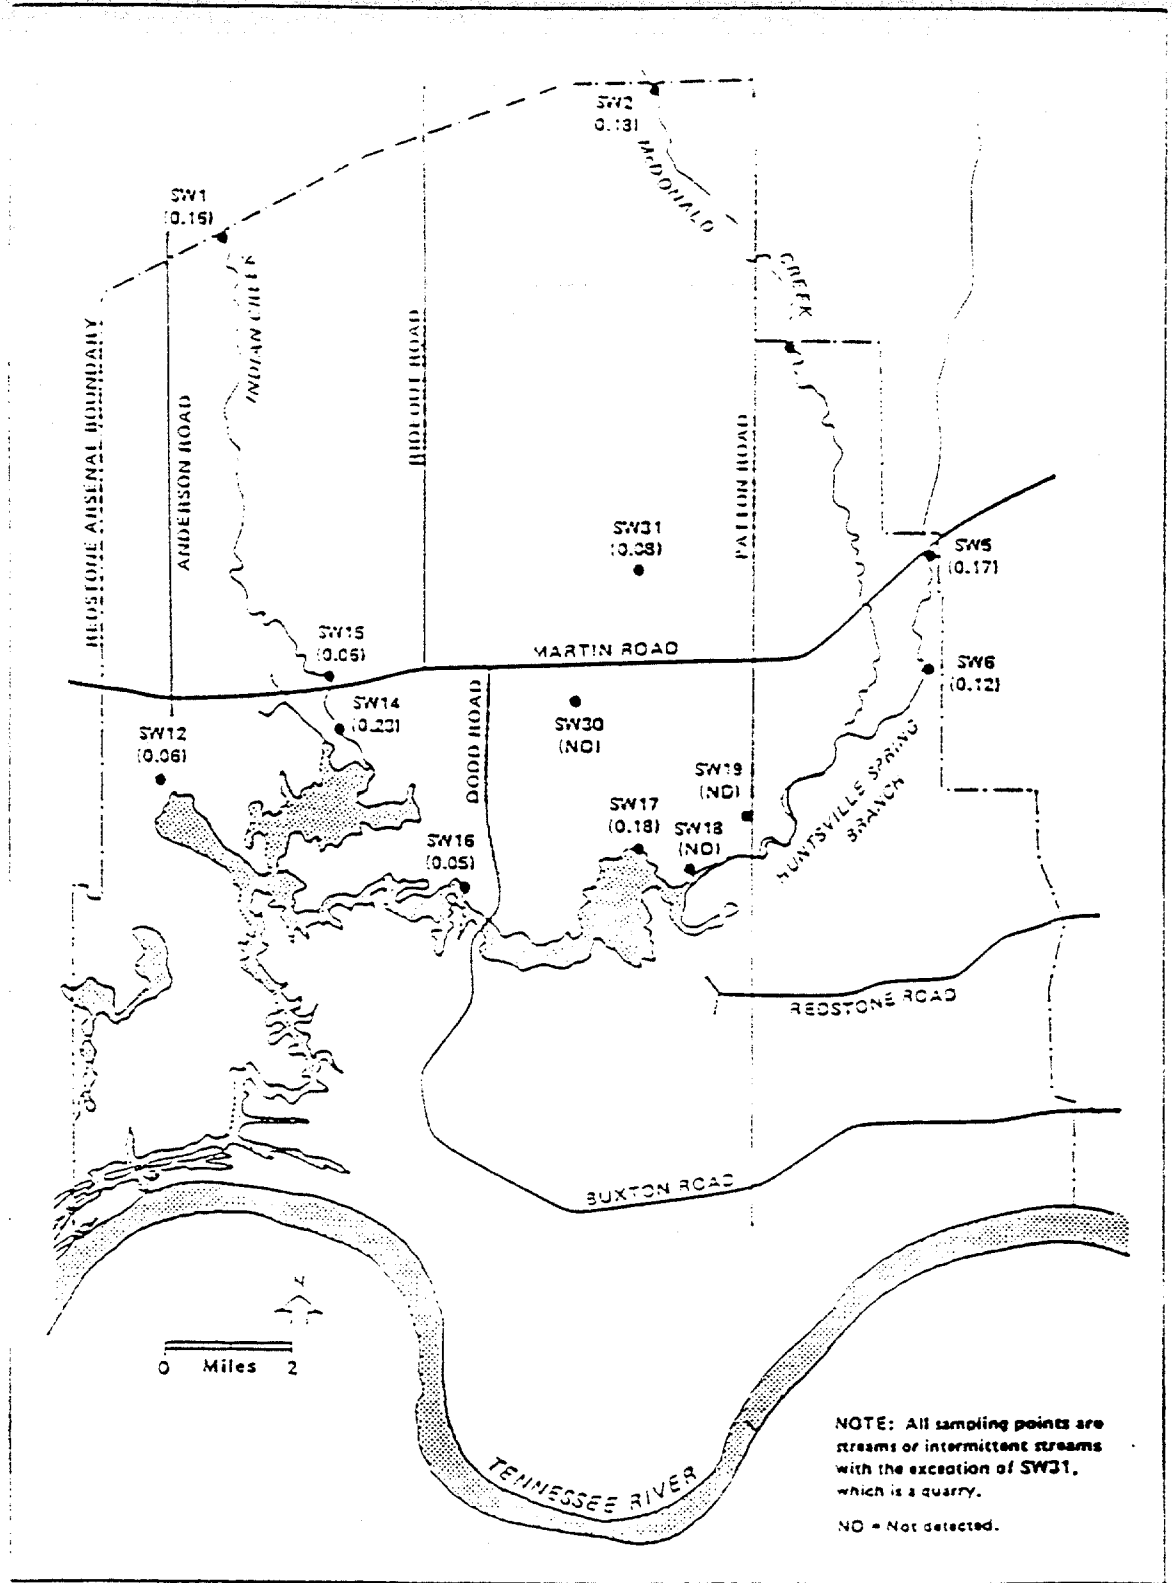
Figure 5. Surface Water Sampling Locations and Results
(expressed as ug/l total detectable DDT)

Surface water samples were collected at 14 on-post locations other than drainage ditches associated with the DDT contaminated areas (Figure 5). These sampling points were upstream of the heavily contaminated Huntsville Spring Branch and Indian Creek, and therefore above the DDT manufacturing zone. At each location, the detectable levels of total DDT are indicated. All water samples were at or below the 0.23 ug/L total DDT detection limit.

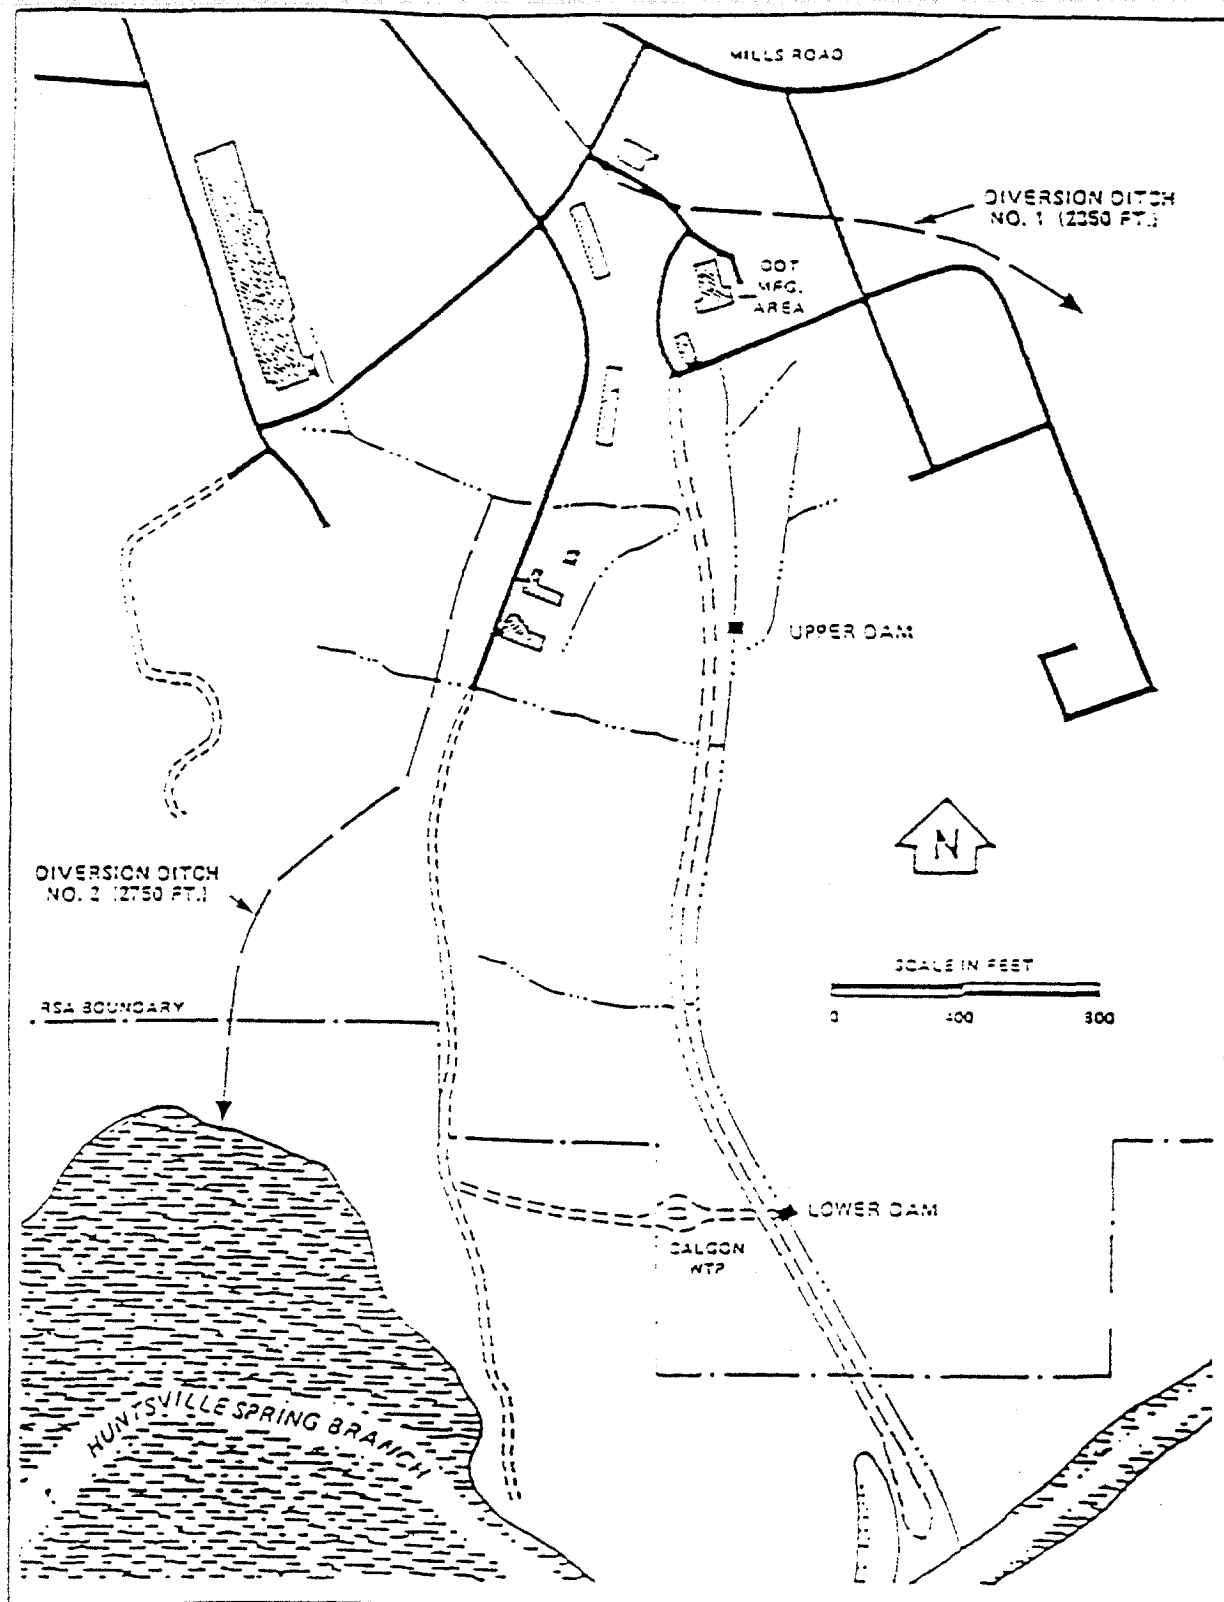
Figure 6. Surface Flow Diversion Associated with
Short-Term Migration Abatement

The effluent limitation from dam No. 4 downstream of the Calgon water treatment plant, was regulated by an NPDES discharge permit (Figure 6). This permit set an effluent limitation of 0.6 ug/l for total DDT. This was the desired detection limit for the RSA sampling program.

<u>Task</u>	<u>Schedule</u>
1. Cleaning the area and initiating topographic survey	12/1/77
2. Filling and sealing the old DDT settling basin	10/28/77
3. Diverting surface drainage from the DDT manufacturing area	11/4/77
4. Installing low level sediment barriers	11/19/77
5. Constructing two retention dams in the DDT discharge ditch	12/1/77
6. Continuing engineering evaluation of carbon adsorption and other DDT removal systems	12/1/77

Diversion ditches and retention dams associated with this work are shown in Figure 6.
